Surface Layer Removal of End-of-Life Carbon Fiber Composites

Faculty Mentor: Dr. Benjamin Rutz | Boeing Mentors: Karly McCauley, Pete George, Isabella DiGiulio

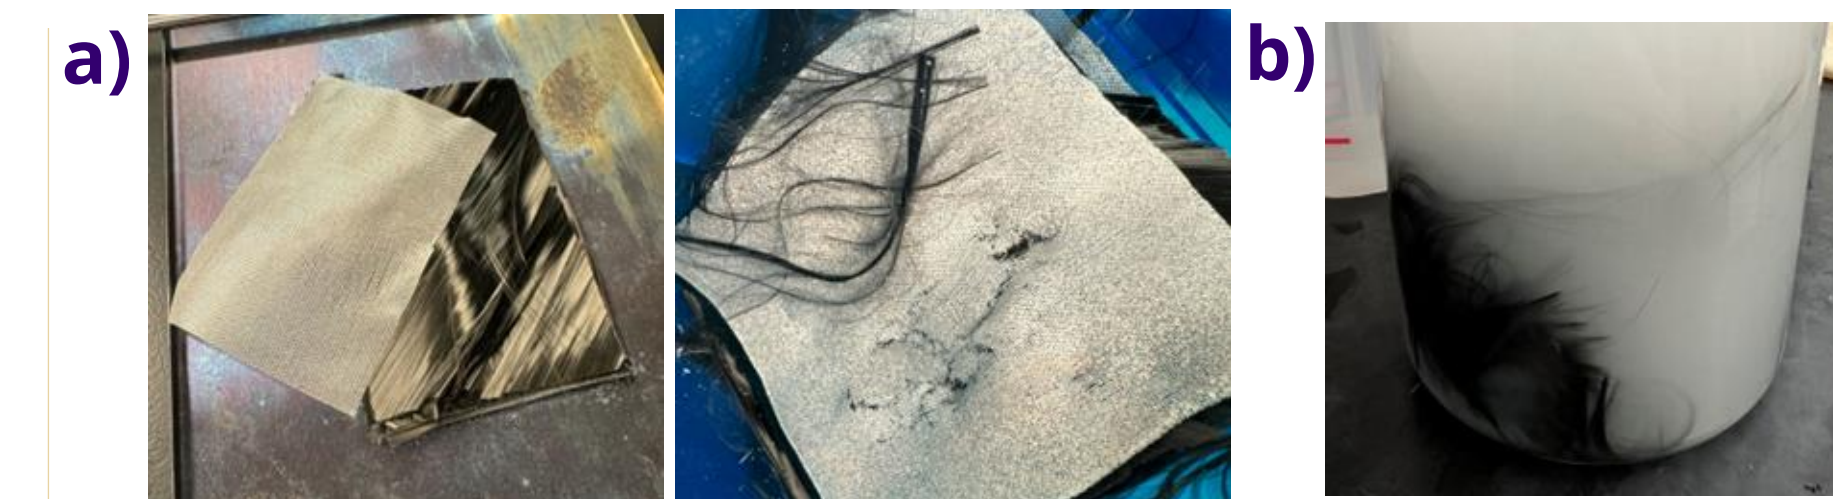
Figure 4. a) Images of the pyrolyzed coupons of 0% and 100% (left to right) removal via media blasting. b) Colloidal suspension to remove paint residue on post-pyrolysis sample.

- > The flow of our project is depicted in Figure 1.
- > Pyrolysis was first run on unaltered samples to select an optimal hold time of 120 minutes under air for all future samples (Fig. 2).
- > Samples run under TGA and pyrolysis were analyzed via Scanning Electron Microscopy (SEM) and Energy Dispersive X-ray Spectroscopy (EDS).
- > Post-pyrolysis samples had paint residue removed via colloidal suspension (Fig. 4).
